IN-HOUSE TECHNICAL INSTRUCTION

ACTION FOR ATTENDING SCRATCHED AXLE

R00.OMR.M91120.BT.0006.B

DESIRO ET 425 M	Power and Trailer Axles Maintenance Instruction - Subsidiary Proposals -

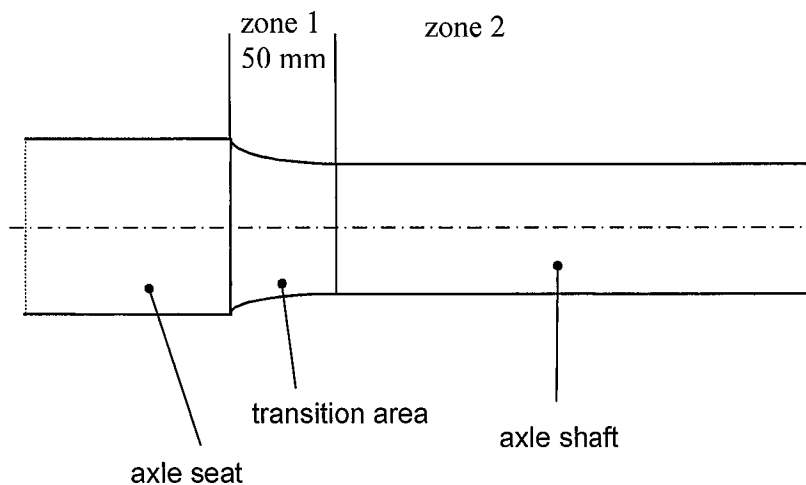
Figure 1: Definition of repair zones

For any type of repair of the axle shaft, the axle is subdivided into 2 parts. Zone 1 is the area within 50 mm in the vicinity of an axle seat, whereas zone 2 is defined as the remaining part of the axle shaft. Any damages in zone 1 are to be removed by using a lathe. During the machining the original contour of the axle re-established. This is valid for the transition radii, permitted form deviations as well as for the surface roughness. The minimum diameter of the axle shaft has to be taken into account.

Local damages like notches and/or corrosion in zone 2 can be removed by using a mobile grinding device. The maximum depth for the local rework is given by the difference between the actual diameter of the axle shaft and the minimum allowed (design) diameter, but in no case more than 1 mm. In the case that the difference between the actual diameter and the minimum diameter will be less than 1 mm, this value has to be chosen.

The grinding operation should be carried out in axial direction. The radius R of the local repair should be greater than 75 mm. No sharp edges should remain between axle shaft and reworked area. The permissible surface roughness is Ra 1.6 μm .

Circumferential damages (e.g. grooves) in zone 2 can be removed by circumferential machining on a lathe. In case of circumferential grooves the maximum depth is the half of the difference between actual diameter and minimum diameter of the axle shaft, but max. 1 mm.
